# Safety Inspection Report

Annual Inspection

## Daintree Green

Hemingford Grey Parish Council

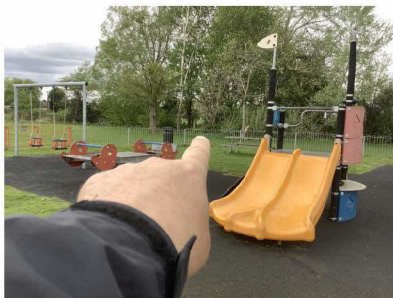
RoSPA recommend the provision of a minimum of two pedestrian gates to reduce the risk of intimidation and bullying.

Consider replacing the maintenance gate to a combination gate. This will allow two access gates for the play area and a maintenance gate for mowers etc.

Add an extra gate.

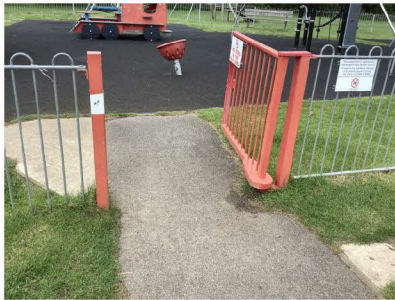
Mechanism needs adjustment.

Adjust.

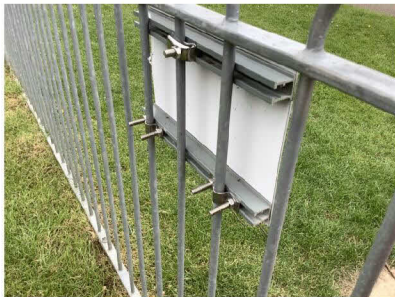
Projecting bolt thread.

Cut off and file down to remove sharp edges or use the correct length of bolt.

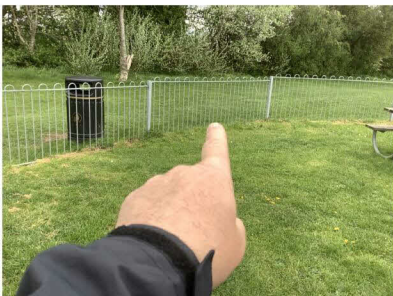
Additional comments are noted below.

Consider replacing the maintenance gate to a combination gate. This will allow two access gates for the play area and a maintenance gate for mowers etc.

Read the notes for further action.

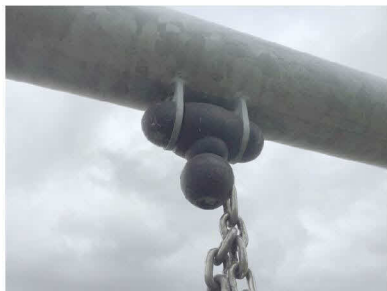
The covers should be removed from the fitting at the top of the chain annually and the shackle bolt should be checked for wear. Check the security of the fittings too.

Replace at 70% of original diameter (30% wear).

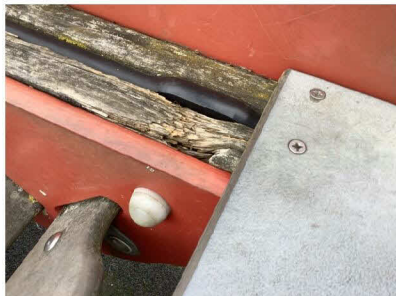
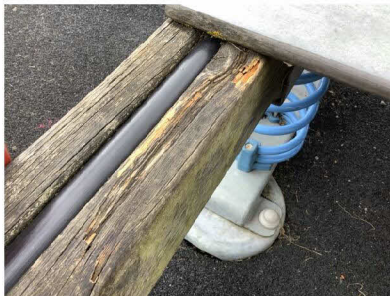
Timber is splintered.

Seesaw plank starting to splinter,.

Repair.

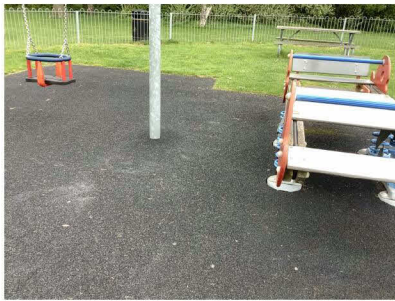
There is an obstacle in the falling space or minimum space.

The falling space is 1200 mm, but should now be 1500 mm for rocking items which users could stand on. This is due to a change in the standard. Monitor this area for any incidents.

No reasonably practicable action is identified.

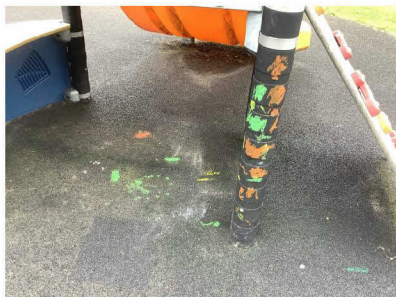
There is graffiti on the unit.

Remove.

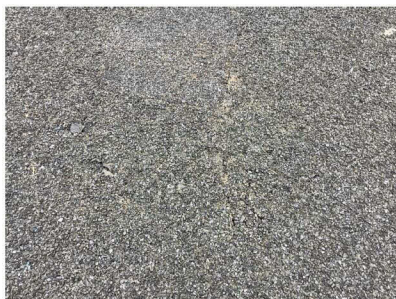
The surface is cracking.

Surface cracking in area. Monitor.

Read the notes for further action.

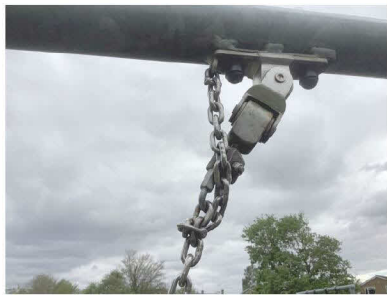
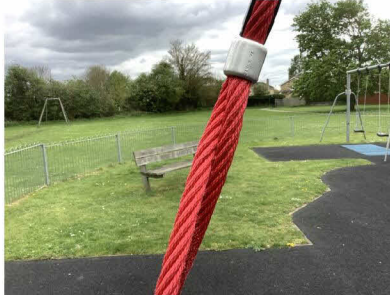
Chains are twisted.

The secondary chains and rope suspension twisted.

Untwist the chains to prolong their life and check for wear.

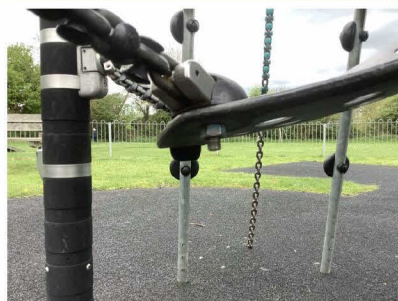
Projecting bolt thread.

Long bolt threads underside of the hammock seat.

Cut off and file down to remove sharp edges or use the correct length of bolt.

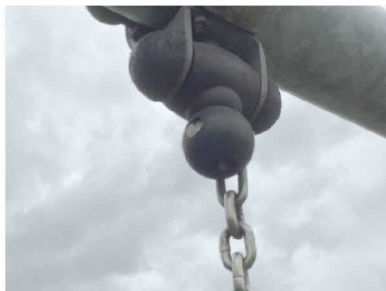
The covers should be removed from the fitting at the top of the chain annually and the shackle bolt should be checked for wear. Check the security of the fittings too.

Replace at 70% of original diameter (30% wear).

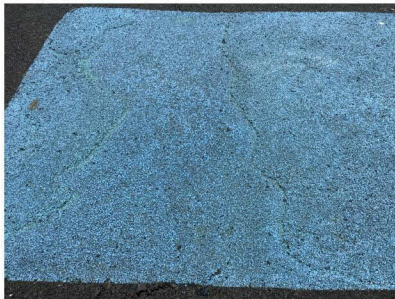
Surface is wearing.

The blue wear pad is wearing/crumbling in places and the joint is opening up.  
Monitor. Further repairs will be required at some stage.

Read the notes for further action.

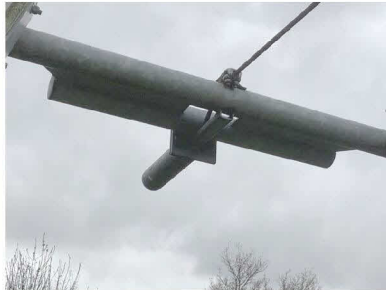
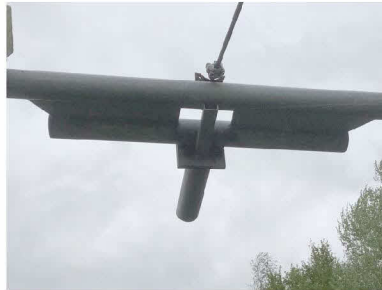
Cables have been known to fail under load due to wear and corrosion. This is generally where the cable enters into a tube, top bar, sleeve or similar, where the wire is in contact and wears and frays over time, but can happen anywhere on the cable. It is important to inspect any hidden parts at least annually. Damaged cables require replacement. This cannot be determined during an annual inspection, and is excluded from our inspection. This can lead to a high risk if no action is taken. Refer to the manufacturer's instructions to ensure the correct check is carried out.

Conduct an appropriate dismantling inspection according to the manufacturer's instructions.

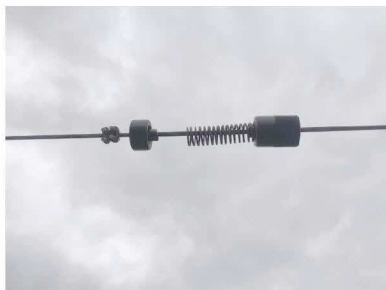
Fixtures loose or missing.

End stop has moved too close to the end crossbeam. Relocate U-bolt further in to the cable; approximately 2 m and secure spring and rubber stop.

Read the notes for further action.

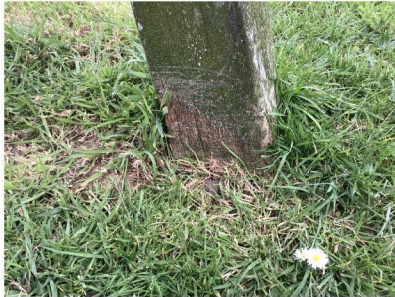
Strimmer damage is present on posts, allowing water to enter and timbers to soften. It can also remove the protective envelope around the timber. Prevent further damage and check timbers for decay throughout the year.

Strimmer damage to the base of the uprights. This will allow water in and shorten the life span of the unit. Re-seal the damaged area and adjust the grass cutting program.

Prevent further damage.
