# Safety Inspection Report

Annual Inspection

## Daintree Green

Hemingford Grey Parish Council

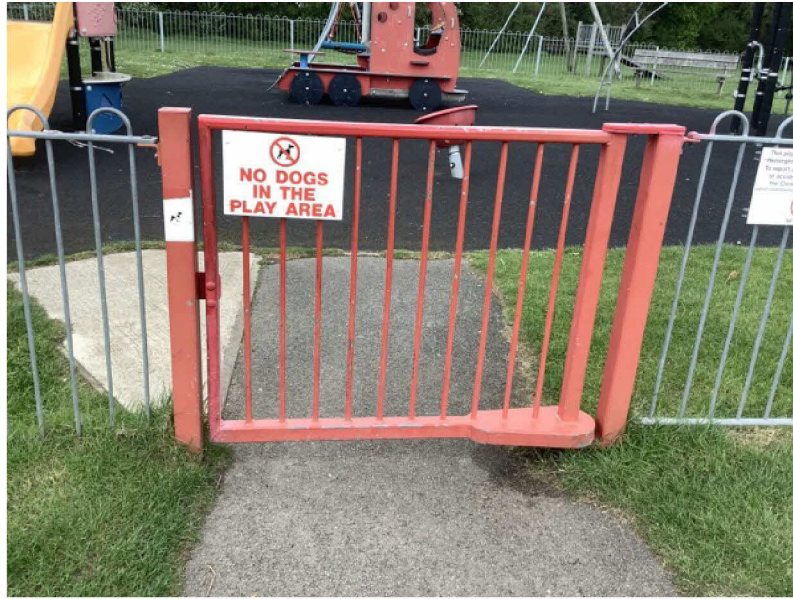
# Gate

RoSPA recommend the provision of a minimum of two pedestrian gates to reduce the risk of intimidation and bullying.

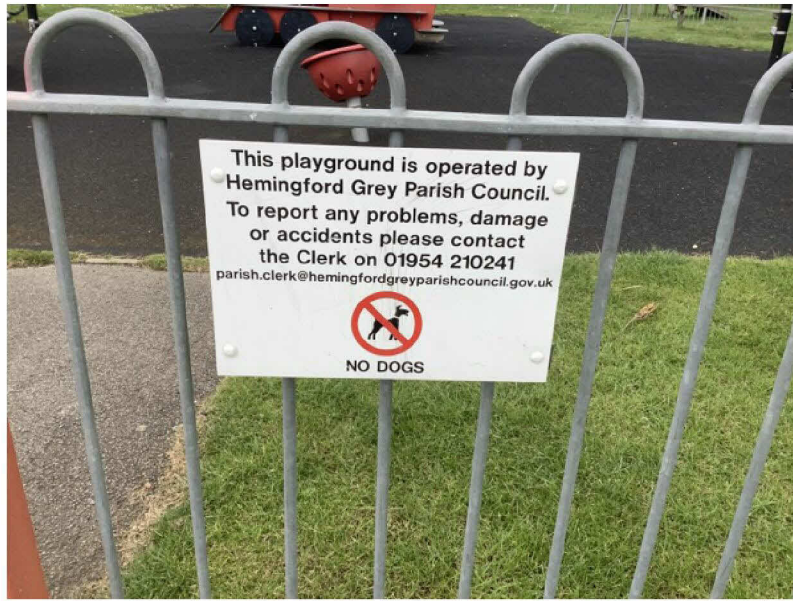
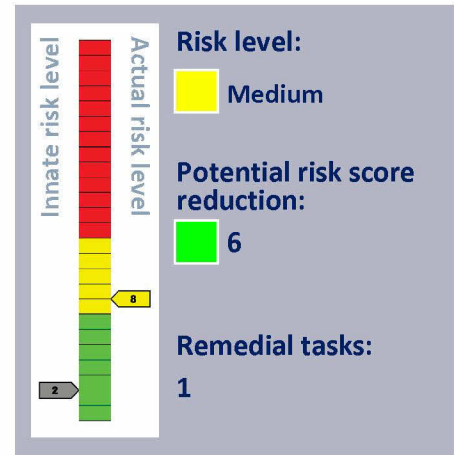
# Signage - Ownership

Description	Tasks	Risk score
Projecting bolt thread.	Cut off and file down to remove sharp edges or use the correct length of bolt.

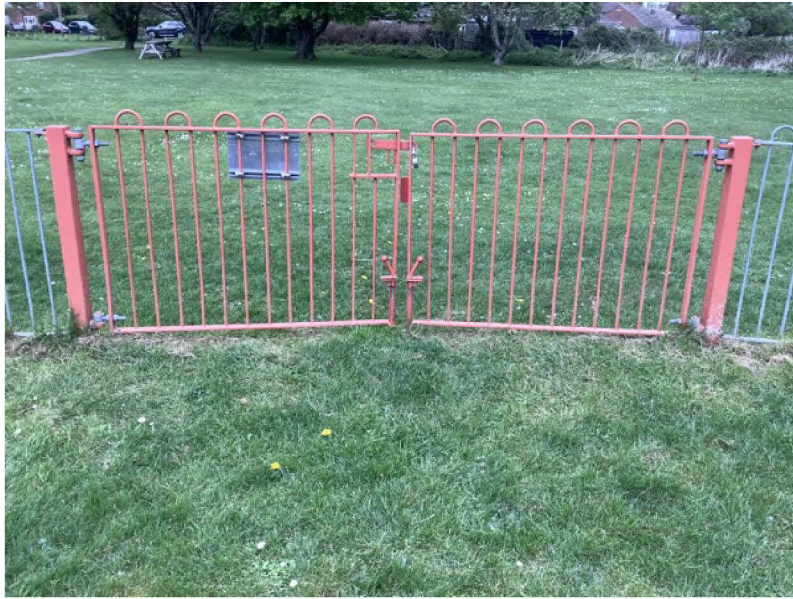
# Gate - Maintenance - Locked

Additional comments are noted below.

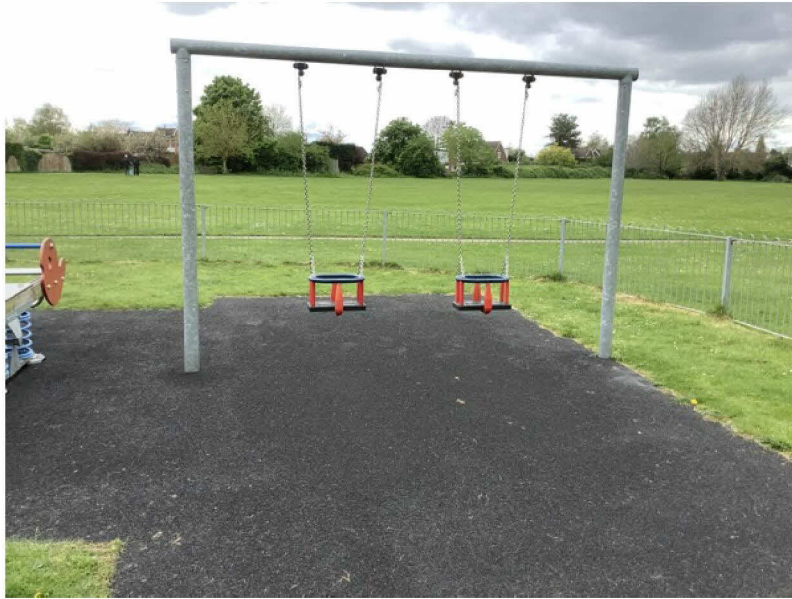
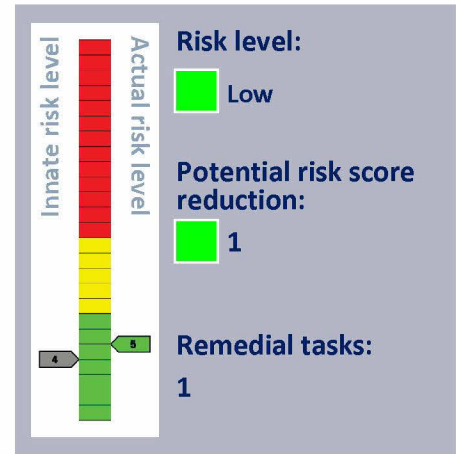
# Swing - Toddler - 1 Bay 2 Seat

The covers should be removed from the fitting at the top of the chain annually and the shackle bolt should be checked for wear. Check the security of the fittings too.

Replace at 70% of original diameter (30% wear).

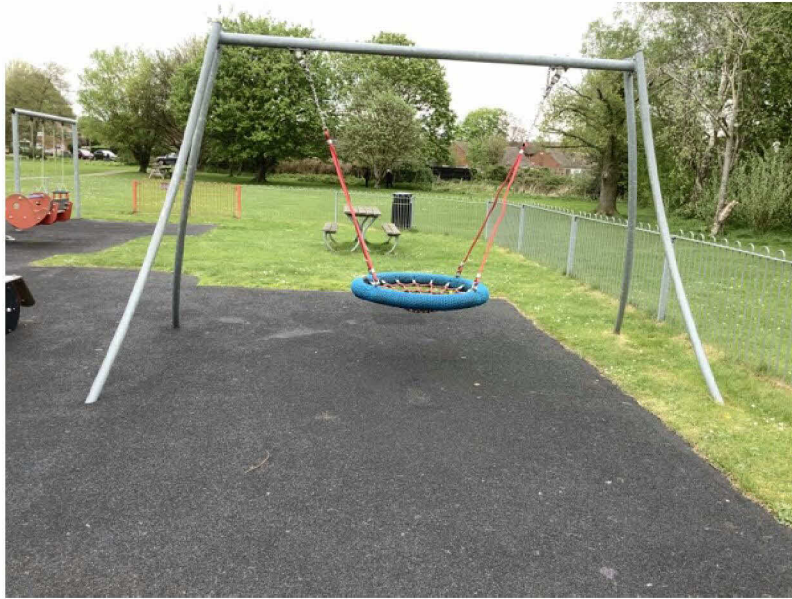
# Swing - Basket

The surface is cracking.

Surface cracking in area. Monitor.

Untwist the chains to prolong their life and check for wear.

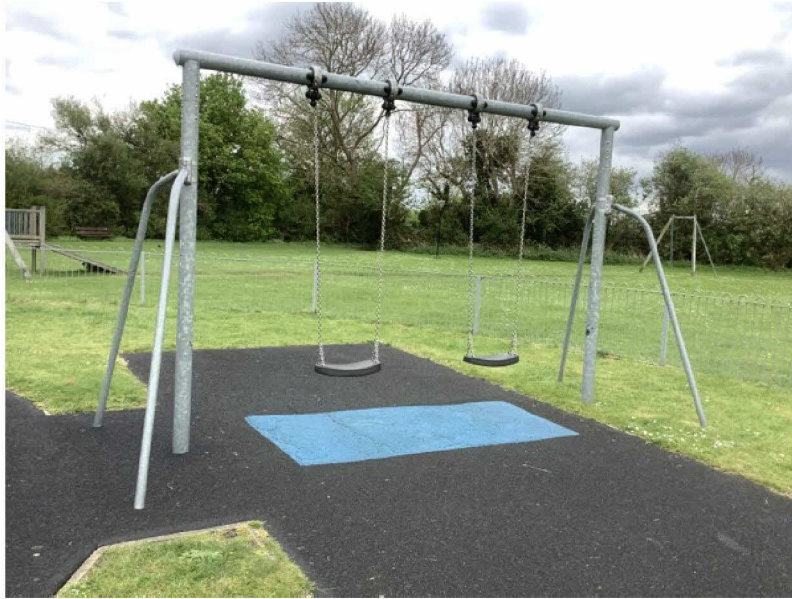
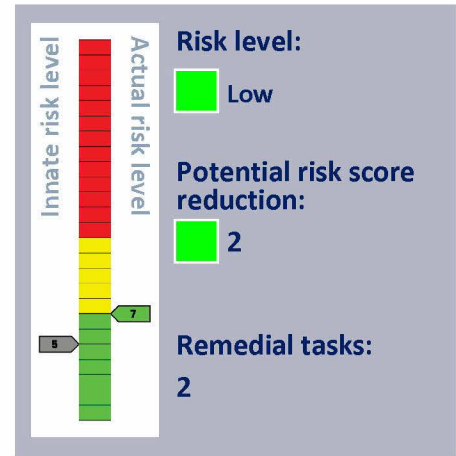
# Swing - Junior - 1 Bay 2 Seat

The covers should be removed from the fitting at the top of the chain annually and the shackle bolt should be checked for wear. Check the security of the fittings too.

Surface is wearing.

The blue wear pad is wearing/crumbling in places and the joint is opening up.  
Monitor. Further repairs will be required at some stage.

Replace at 70% of original diameter (30% wear).

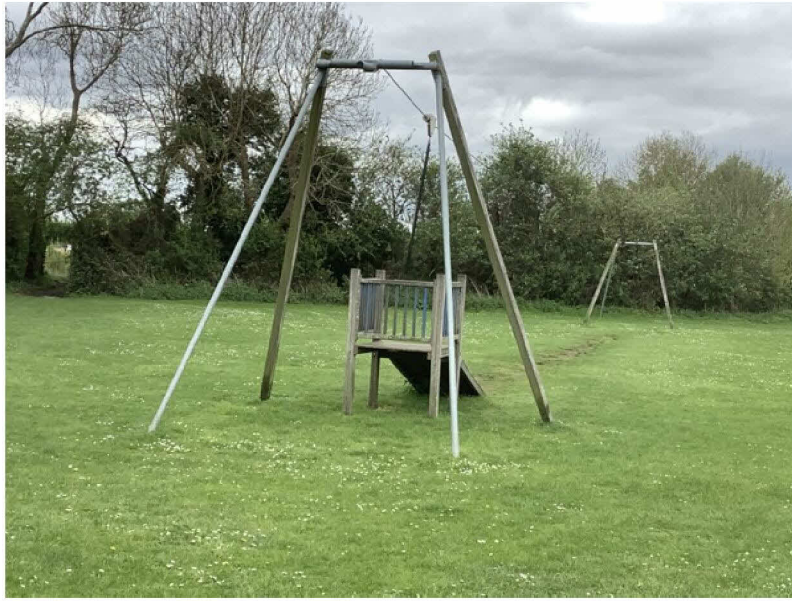
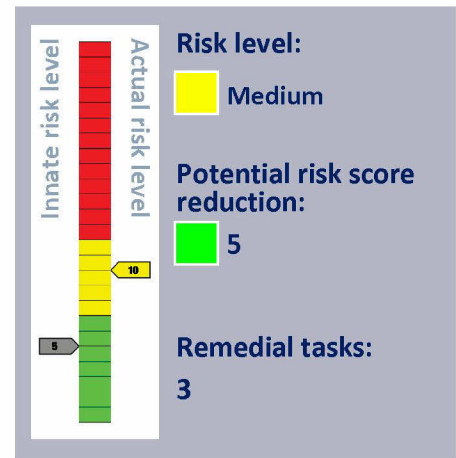
# Cableway

Cables have been known to fail under load due to wear and corrosion. This is generally where the cable enters into a tube, top bar, sleeve or similar, where the wire is in contact and wears and frays over time, but can happen anywhere on the cable. It is important to inspect any hidden parts at least annually. Damaged cables require replacement. This cannot be determined during an annual inspection, and is excluded from our inspection. This can lead to a high risk if no action is taken. Refer to the manufacturer's instructions to ensure the correct check is carried out.

Fixtures loose or missing.

Strimmer damage is present on posts, allowing water to enter and timbers to soften. It can also remove the protective envelope around the timber. Prevent further damage and check timbers for decay throughout the year.

Strimmer damage to the base of the uprights. This will allow water in and shorten the life span of the unit. Re-seal the damaged area and adjust the grass cutting program.

Prevent further damage.
