# Safety Inspection Report

Annual Inspection

## Open Space off Dunnock Way

Hemingford Grey Parish Council

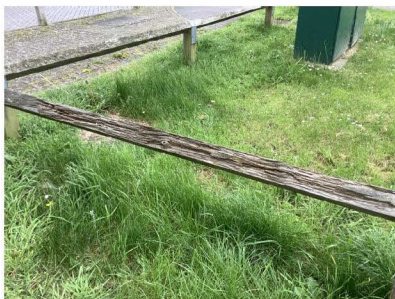
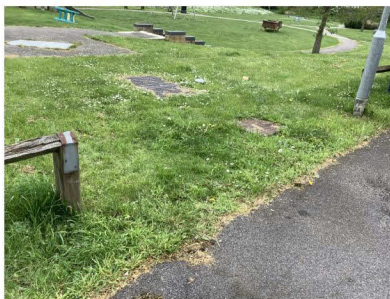
There is decay to timber components which may affect structural integrity. We do not recommend replacing rotten supports with timber posts which are directly set in the ground due to the increased problem of timber rot, especially in posts in contact with the ground.

Decayed and missing rails.

Replace decayed components where possible and plan replacement of item. Check on a routine basis, especially at ground or foundation level.

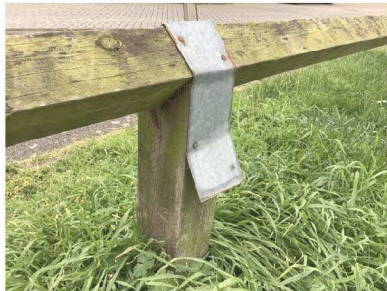
Item is not secure.

Rail straps detaching.

Secure.

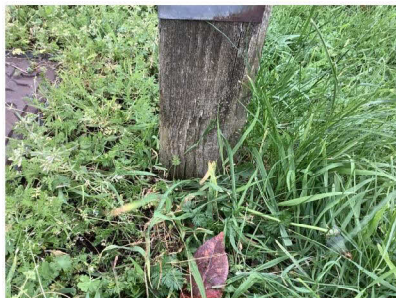
Strimmer damage is present on posts, allowing water to enter and timbers to soften. It can also remove the protective envelope around the timber. Prevent further damage and check timbers for decay throughout the year.

Prevent further damage.

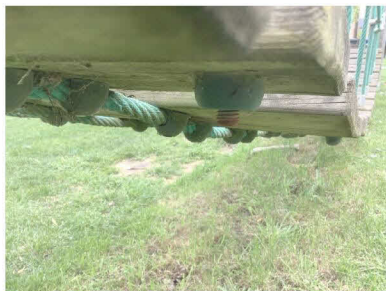
Cap missing.

Cap missing underneath the bridge.

Replace.

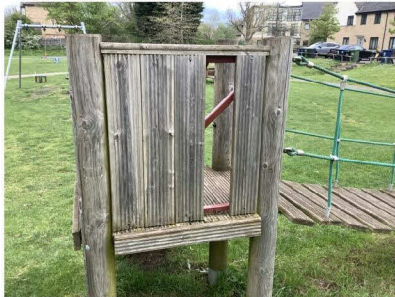
Item has some parts missing.

Barrier slat missing.

Replace the missing parts.

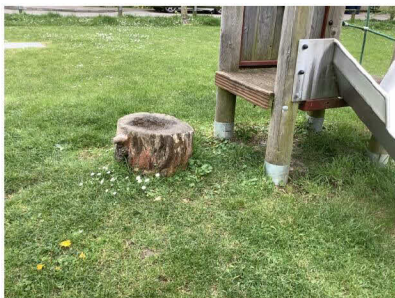
Additional comments are noted below.

A tree stump has been installed at the slide platform access opening. Monitor, as this is not a correct component for this unit.

Read the notes for further action.

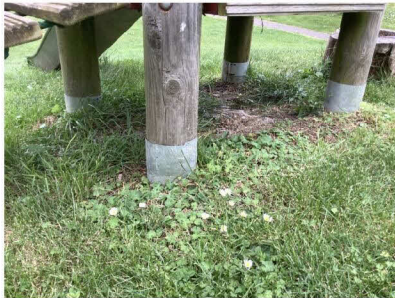
Strimmer damage is present on posts, allowing water to enter and timbers to soften. It can also remove the protective envelope around the timber. Prevent further damage and check timbers for decay throughout the year.

Strimmer damaged has been covered up by metal plates. We are unable to inspect this area for decay with the plates in place.

Prevent further damage.

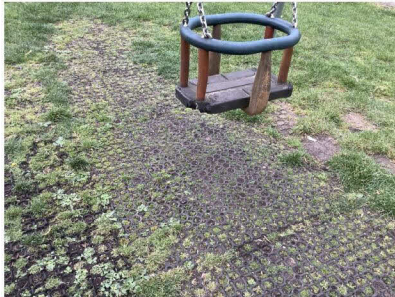
There is wear to the surfacing due to foot drag.

Raise seats up to 500 mm to the bottom of the seats.

Read the notes for further action.

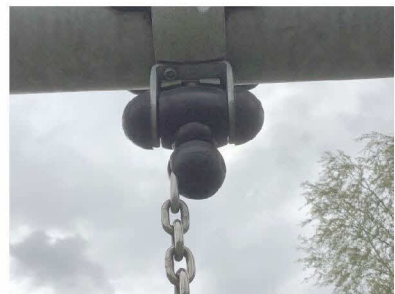
The covers should be removed from the fitting at the top of the chain annually and the shackle bolt should be checked for wear. Check the security of the fittings too.

Replace at 70% of original diameter (30% wear). Check the security of the fittings.

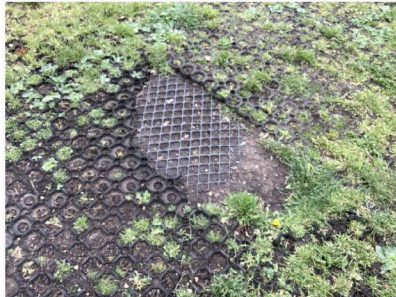
Surface needs repair.

Grass mat damaged and missing.

Replace.

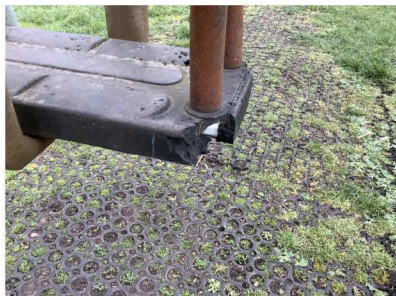
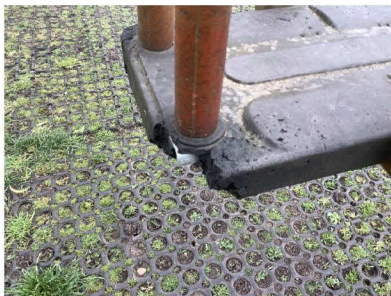
Swing seat is damaged.

Cradle seat damaged exposing the metal frame.

Replace.

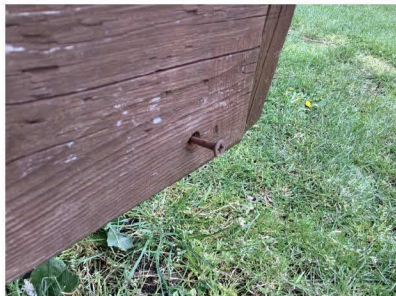
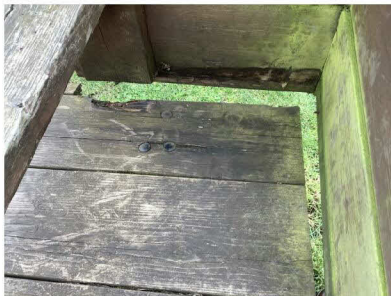
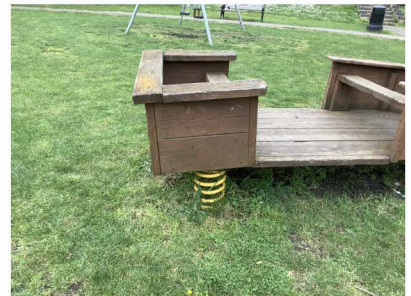
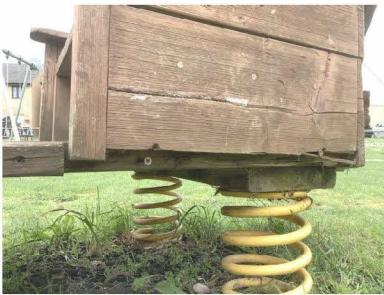
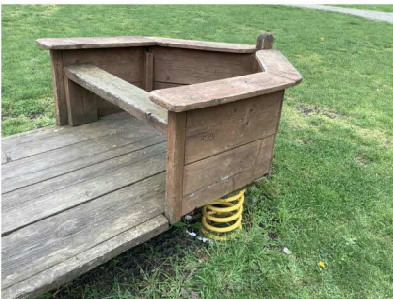
Item is not secure.

Both front and rear barriers of the boat have detached from the base of the boat exposing screw heads. Repair as soon as possible.

Secure.

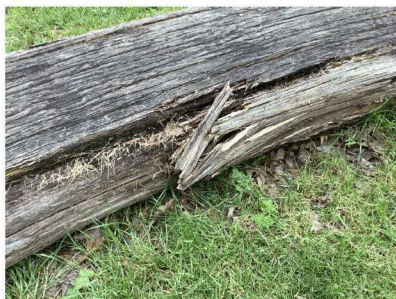
Timber is rotting.

Log walk decaying. Monitor.

Read the notes for further action.

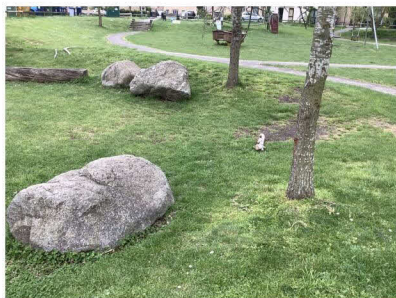
The item is not compliant with the requirements of the relevant standards. The surfacing meets with the requirements of the relevant standards.

There is an obstacle in the falling space or minimum space.

Trees are in the fall area (700 mm).

Eliminate the hazard.
